REAL WORLD INTERFACES

Engineering Change Order ECO-DFTB-08-00: MIDI In and Out Systems prior to February 2016 which may cause pitch fluctuations in notes played by the Internal Sequencer

Robin Whittle 7 February 2016 www.firstpr.com.au/rwi/dfish/

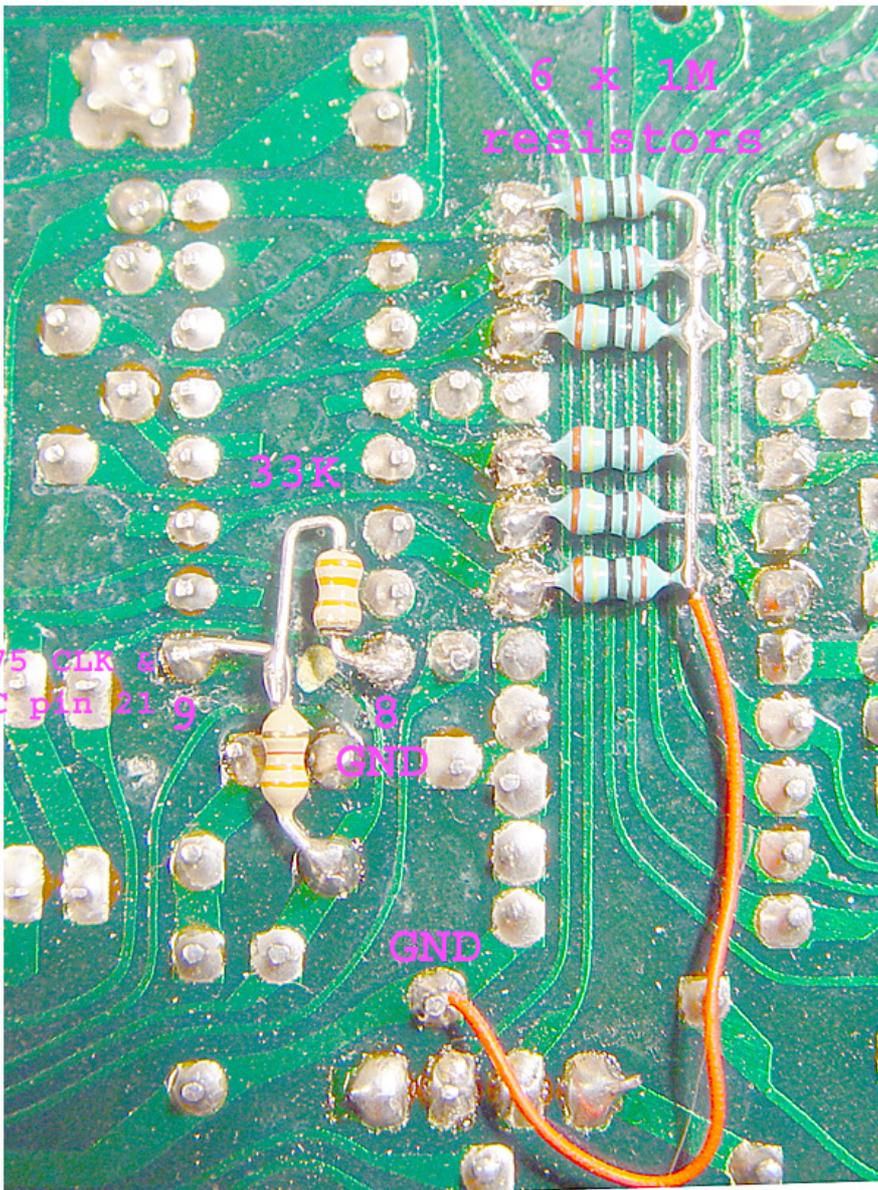
The CV fluctuation is due to leakage currents inside the PIC16F1936 microcontroller – specifically a positive current (raising the voltage) flowing inside the chip into pin 2, which is used as an input to the PIC's ADC, as part of the MIDI Out system.

The primary cause of the leakage current is PIC pin 21, which is driven via a 3.3k resistor (I install it on the back of the main TB-303 board) from the Clock pin 9 of the 4174 hex latch, which stores the 6 bit DAC value. The 4174, which is like a 74C174, is driven from a precise 5.333 volt supply. Normally, in the unmodified TB-303, its data input pins and its clock pins are driven directly from the TB-303 CPU pins. In the Devil Fish with MIDI In or MIDI In and Out, the data pins of the 4174 are driven via 100k resistors from the TB-303 CPU. These 6 data pins are also connected to PIC input pins 16 and 22 to 26.

The single pin 21, driven via a 3.3k resistor, is a much stronger source of leakage current than the combination of all six data pins driven via 100k resistors.

- 1 - A 0.125 watt (or at least a similarly small axial resistor, even if its wattage rating is higher) 33k resistor between ground and the Clock pin 9 of the 4174. In this way, the Clock pin and the blue wire (soldered to pin 9 on the top side of the board, which you can't see if only the rear part of the case is removed) driving pin 21 of the PIC is the result of a 3.3k to 33k voltage divider. This means that the 4174 and the PIC get 10/11 of the voltage produced by the TB-303 CPU pin, and that pin's most positive voltage is now reduced somewhat by this new path to ground. Solder the resistor between pin 8 (ground) and the 3.3k resistor's wire to pin 9. It is best to solder the pin 9 connection to the lead of the 3.3k resistor, rather than to pin 9 itself, in case the heat from the soldering iron desolders the blue wire on the top side which is soldered to that pin. Fixing this would involve some disassembly and reassembly.

- 2 - Solder six 1M 0.125 watt resistors so that the right end goes to the right end of one of the 6 new 100 k resistors I installed in place of wire links, and so the left ends all go to ground.

The following photo shows how this can be done.
