REAL WORLD INTERFACES

Memory Backup for the Modified TR-808

Robin Whittle 20 October 2015

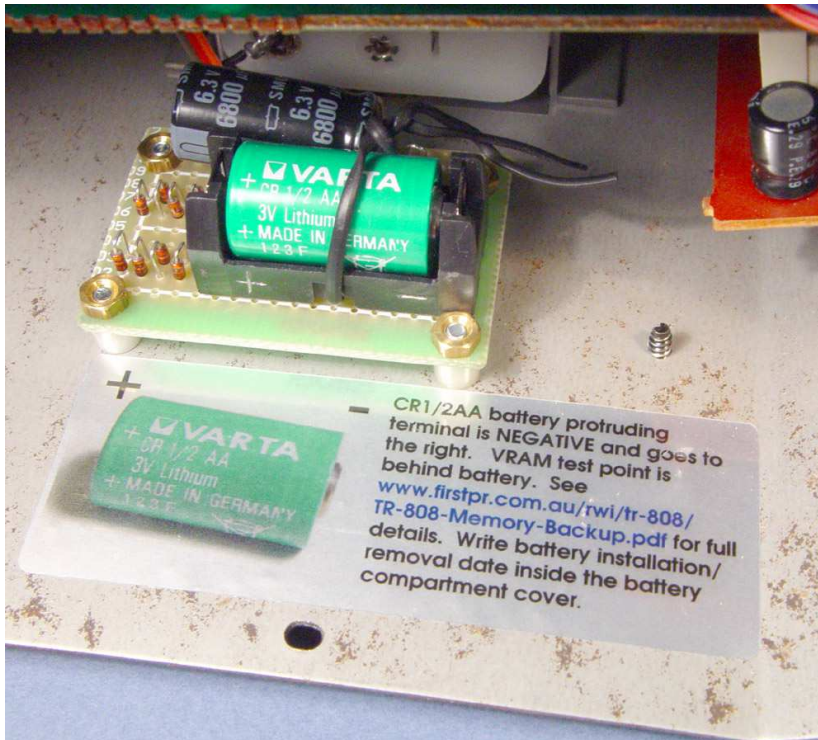
5 -   The battery can now be inserted in its holder, with the positive end towards the front of the machine, which is to your left. Unlike conventional batteries, these lithium batteries have their protruding terminal as the minus (-) terminal, which should be to your right. A twistable cable-tie is already installed around the battery holder. Twist it around the battery to keep the battery in position even if the machine is subjected to a sudden bump which might otherwise dislodge it. Here is a photo of the battery board:
